A CEMENT MILL FAILURE

THE CASE OF THE CEMENT MILL FAILURE

Subject : TRUGRIT Cement Mill Trunion Failure

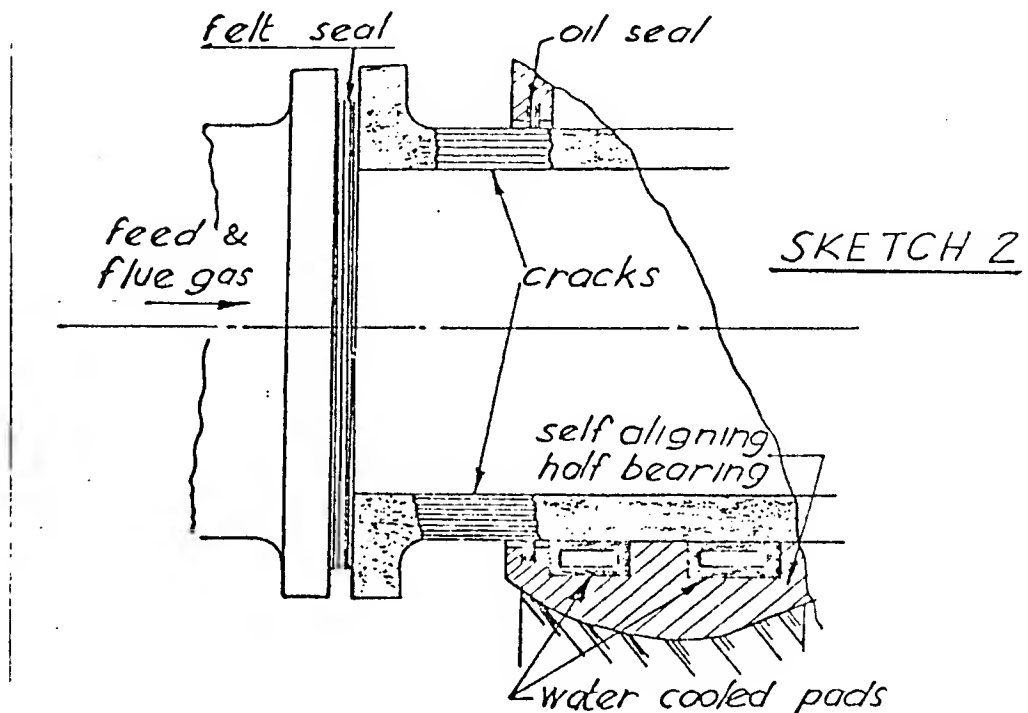
The mill engineer inspected the trunnion and called SONIC Engineering, a consultant in non-destructive testing. Their report showed two cracks diametrically opposite each other and running from the inlet flange to the point just inside the bearing cover (approximately 250mm). Both cracks are parallel to the axis of rotation.

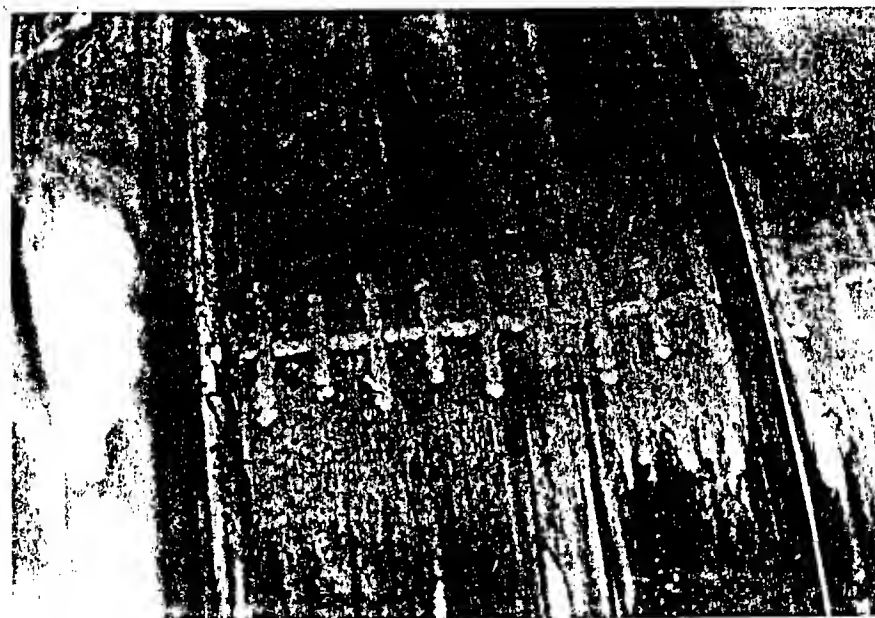
Exhibit D.

Description of Metalocking process and photo of Metalocked crack.

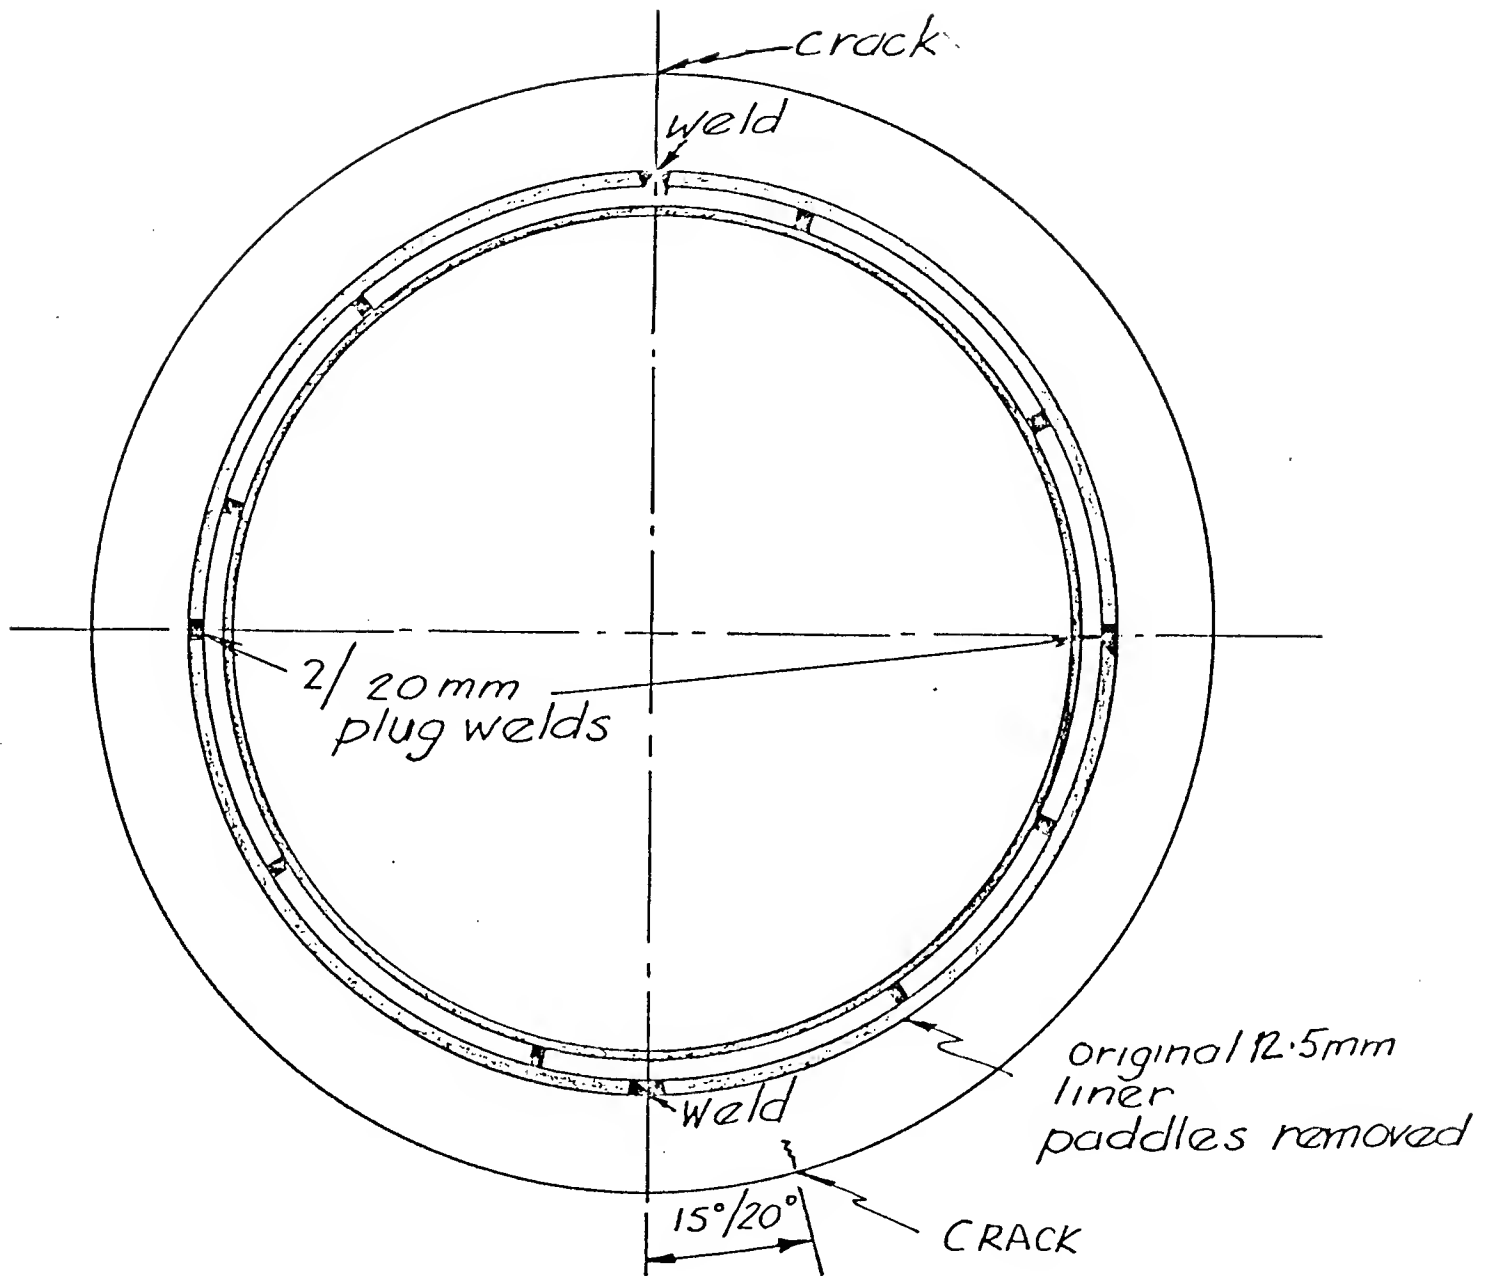
Exhibit E.

10mm inner liner installed 5/27/72
15mm spacer positions not known.

Raw Mill Feed End Trunnion - Location of Cracks and Liner Welding.

The sites of failure are sufficiently close to the construction welds of the original trunnion liner to suggest that the welds are responsible for crack site initiation. This initiation process may have occurred due to a weakened metal structure or high stress due to improved metal to metal contact at the weld sites.

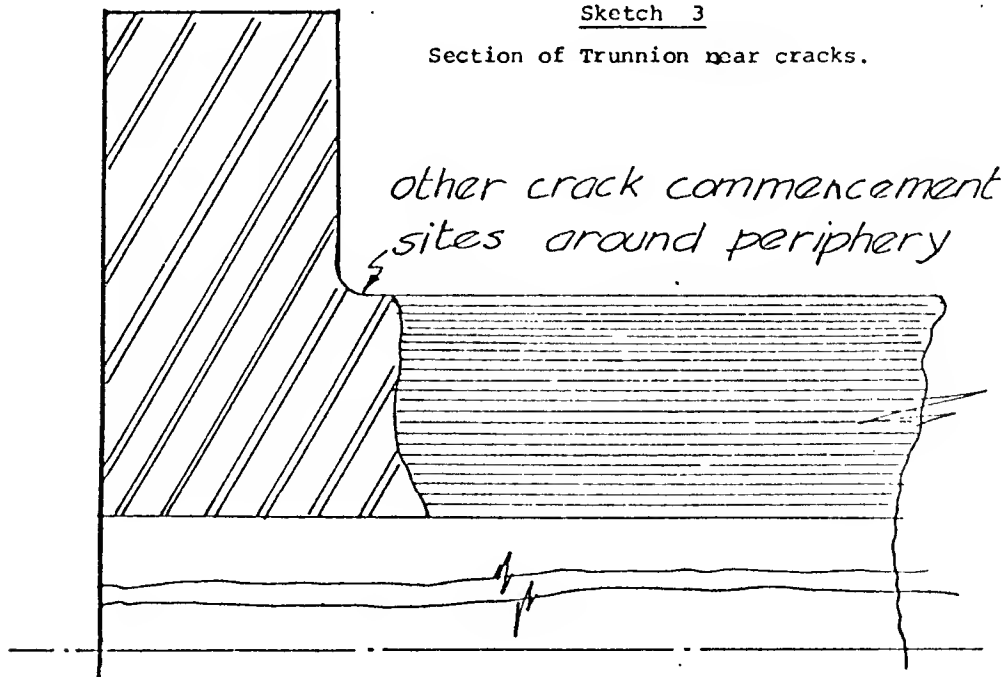
Sketch 3

A few simple calculations further confirmed Amory in his initial sizing up of the problem. The hoop stress, caused by even the conservatively large structural loads assumed to act on the inlet end of the trunnion he found to be negligible. Nevertheless Amory went to considerable trouble to eliminate from consideration structural stresses as possible causes of failure. He reasoned that if structural loads were involved in the failure there should be some evidence of other hairline fatigue cracks on the trunnion apart from the two major cracks under investigation. He figured that the base of the feed end flange would represent a likely source of stress concentration associated with some kind of complex trunnion-flange twisting or bending process. There seemed no obvious reason for the major cracks occurring where they did and a random process would have produced other crack commencement sites as well. For these reasons Amory planned to take some penetrant dye to check out the trunnion on his next visit to the plant.

Section of Trunnion near cracks.

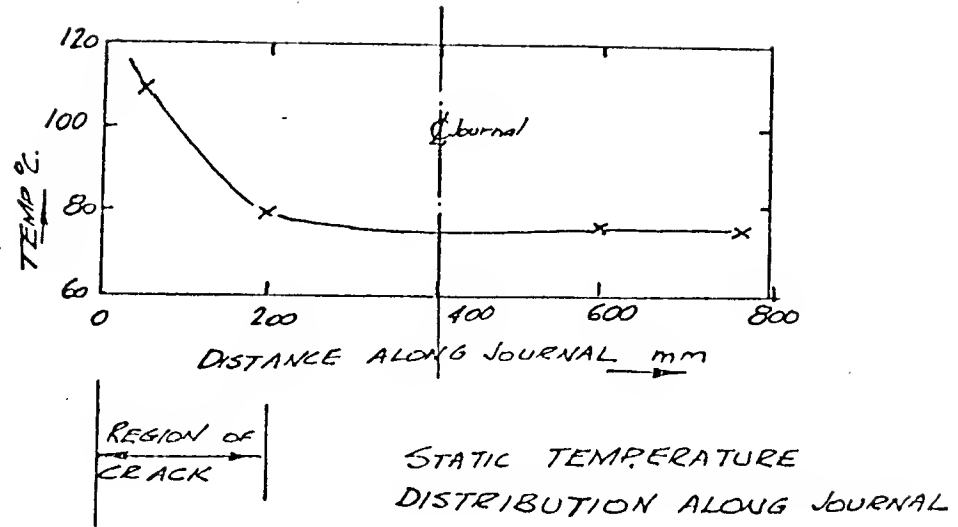
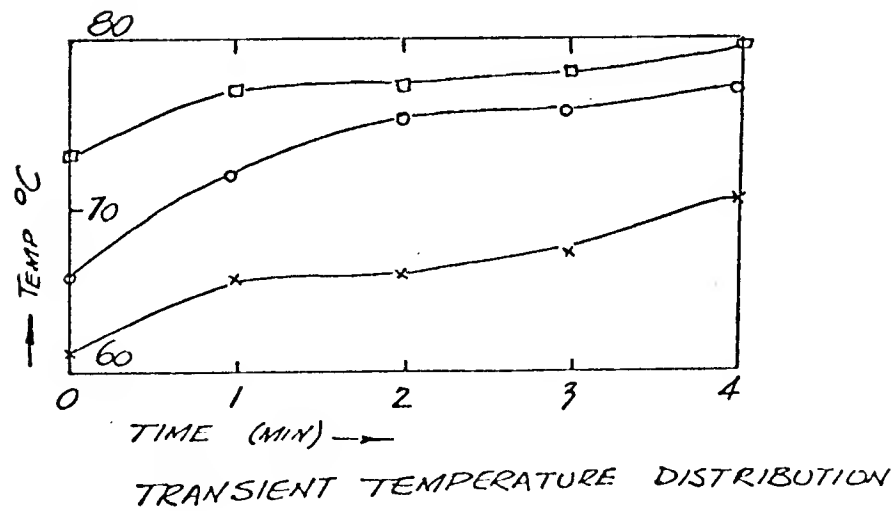
Exhibit F. (cont'd)

During the time the mill was stopped Amory observed a 10° to 12° C. rise in temperature at the inlet end of the trunnion. His curiosity aroused, he visited the control room to find that the flue gas inlet temperature to the mill was recorded continuously. The records showed that the gas temperatures can rise to a high of 450°C. in a very short time on a scale of minutes. Further investigation showed that the flue gas comes from a kiln just upstream of the mill. Since the kiln cannot be shut down simultaneously with the mill, the sequence of operations during a mill shut-down is critical. Even when the mill is running, feed blockages can occur. The flue gas is used to dry the feed and in a sense the feed provides a kind of evaporative cooling of the flue gas. If the flue gas is not allowed to bypass the mill during shut-downs or feed blockages, then inlet gas temperatures will soar to very high values. In the mill operation the bypassing process was found to be a manual operation. Since the feed stoppage is a random event, inlet temperature rises can and do occur depending on the alertness of the operating

Temperature distribution in trunnion.
